Dell Data Security

Endpoint Security Suite Pro Technical Advisories v1.8

Endpoint Security Suite Pro Technical Advisories

Rev. A01

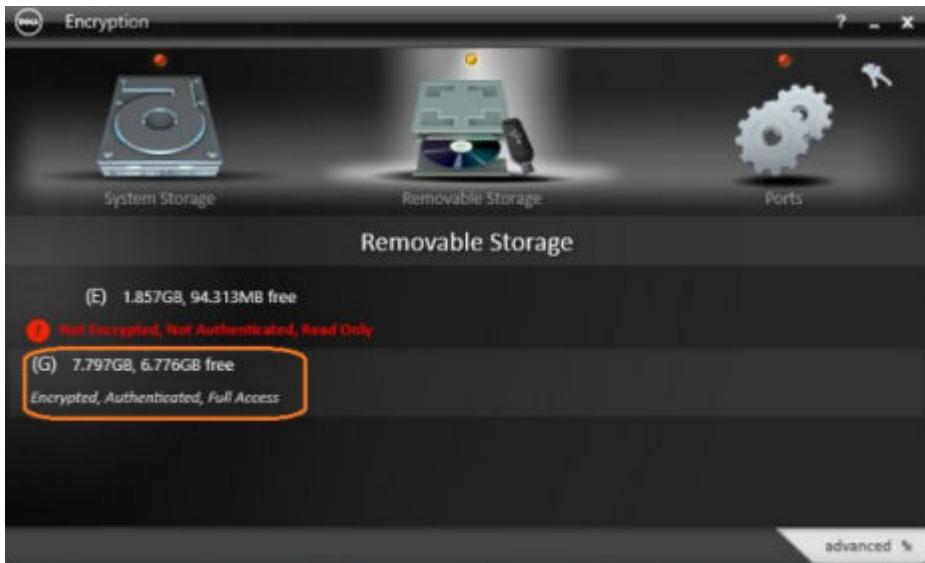
- The Secure Hibernation policy is not supported with Legacy BIOS on Windows 7. [DDPC-2279]
- Encryption status displayed in the Dell Data Security application for a fixed or removable drive may differ from the actual status of the drive, which is correctly displayed in the Local Management Console.

[DDPC-5521, DDPC-5670]
