# Upgrading to Dell EMC vSphere and vSAN version 7.0

This technical white paper detail about some of the guidelines Dell EMC provides prior to upgrade to vSphere 7.0 from the previous branches of vSphere and vSAN versions.

June 2020

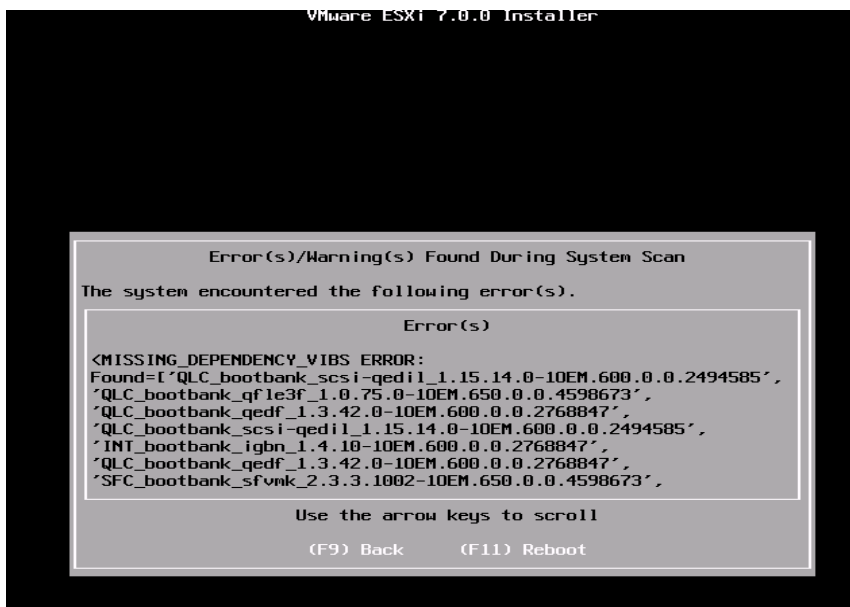
The following driver packages fail when you attempt to upgrade Dell EMC customized 6.5.x to 7.0.

- igbn
- ixgben
- qfle3f
- qedf
- sfvmk
- scsi-qedil

Below is an example screenshot of the upgrade failure when you attempt to upgrade from a Dell EMC customized 6.5.x image to 7.0 using ISO/CD based method.

Figure 1 Upgrade failure from 6.5.x to 7.0 using ISO/CD

You must remove the above-mentioned driver packages prior attempting an upgrade using the command: `esxcli software vib remove -n igbn -n ixgben -n qfle3f -n qedf -n sfvmk -n scsi-qedil`.

Before upgrading, the ESXi needs to be gracefully rebooted to complete the driver packages removal. See the [VMware Knowledge Base article 78389](#).

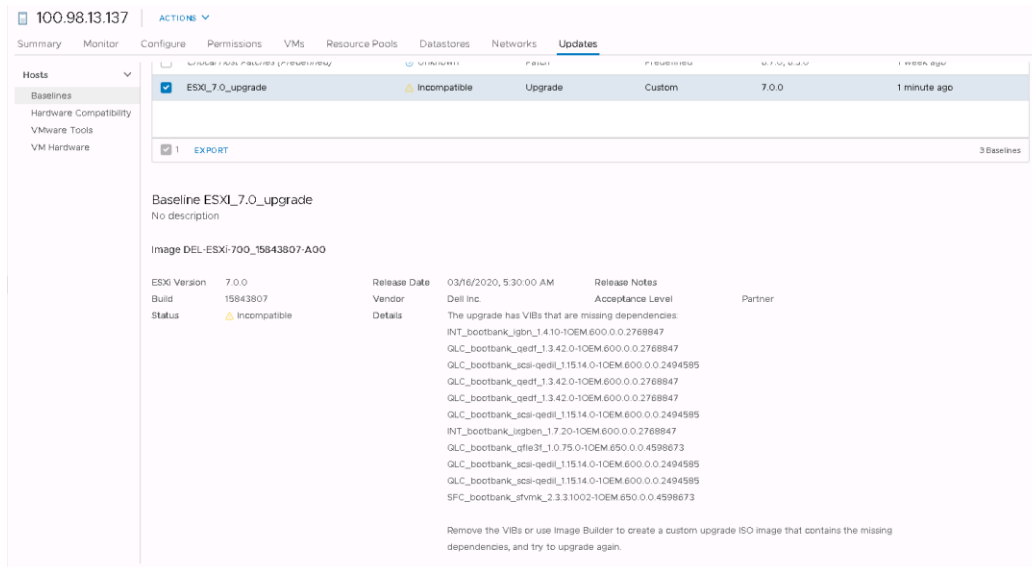
Below is an example screenshot of the upgrade failure when you attempt to upgrade Dell EMC customized 6.5.x image to 7.0 using VMware Update Manager (VUM).

Figure 2 Upgrade failure from 6.5.x to 7.0 using VUM

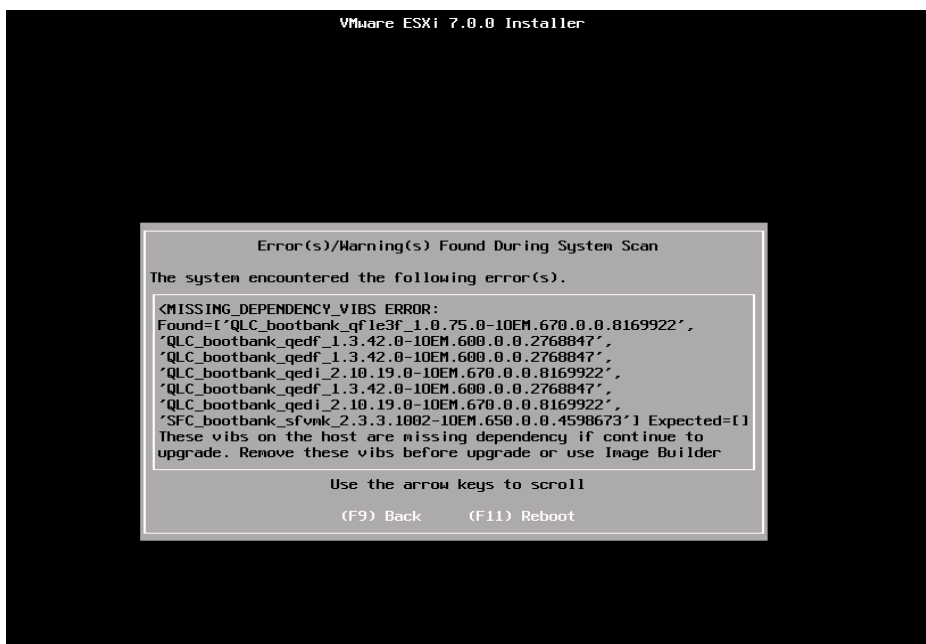
This section describes on the errors you might observe when you attempt to upgrade Dell EMC customized vSphere 6.7.x to 7.0. The following driver packages fail when you attempt to upgrade from a Dell EMC customized 6.7.x to 7.0:

- qedf
- qfle3f
- sfvmk
- qedi

Below is an example screenshot of the upgrade failure when one attempt to upgrade Dell EMC customized 6.7.x image to 7.0 using ISO/CD method.

Figure 4 Upgrade failure from 6.7.x to 7.0 using ISO/CD Method

You must remove the above-mentioned driver packages prior attempting an upgrade using the command:  
`esxcli software vib remove -n qedf -n qfle3f -n sfvmk -n qedi.`

Before upgrading, the ESXi needs to be gracefully rebooted to complete the driver packages removal. See the [VMware Knowledge Base article 78389](#).

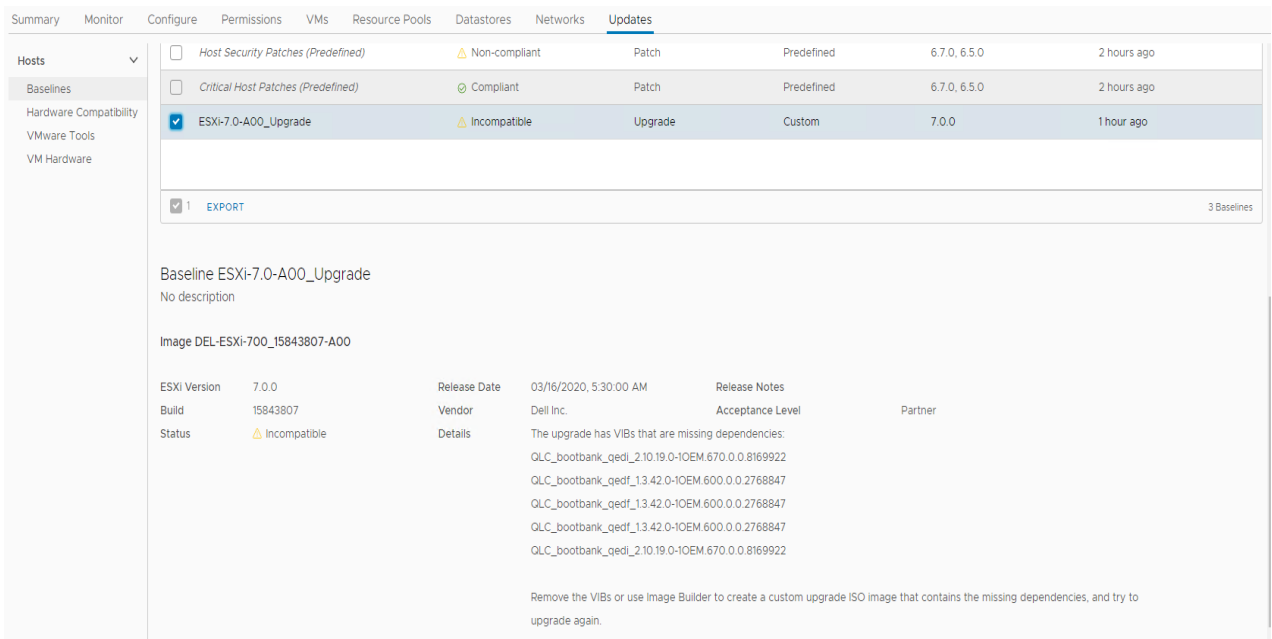
Below is an example screenshot of the upgrade failure when you attempt to upgrade Dell EMC customized 6.7.x image to 7.0 using VMware Update Manager (VUM).

Figure 5 Upgrade failure from 6.7.x to 7.0 using VUM

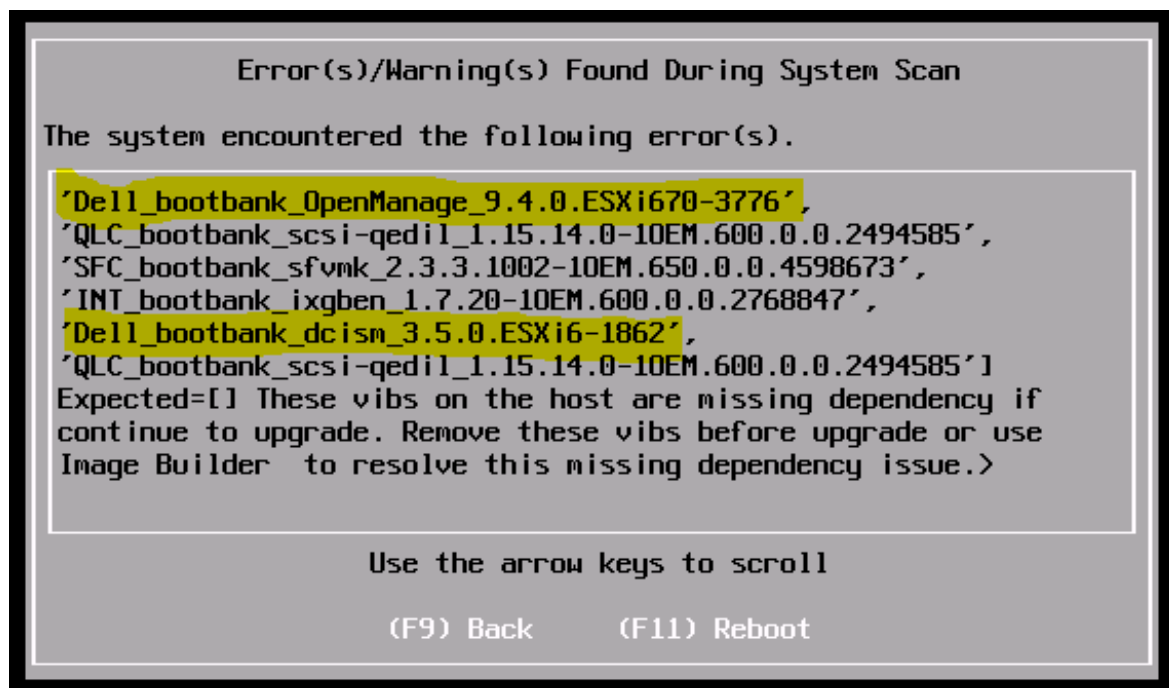
When the prerequisites are not followed, an upgrade task fails with the error shown below.

Figure 7 Upgrade failure with incompatible systems management software installed

Dell EMC supports variety of in-band systems management packages (CIM providers) on customized versions of ESXi. However, CIM providers are not integrated into the customized image by default. Some of the in-band CIM provider packages supported on ESXi are [OpenManage Server Administrator \(OMSA\)](#) and [iDRAC Service Module \(iSM\)](#) on ESXi. These software packages are posted at Dell support page and the download instructions are documented in the OMSA and iSM documentation.

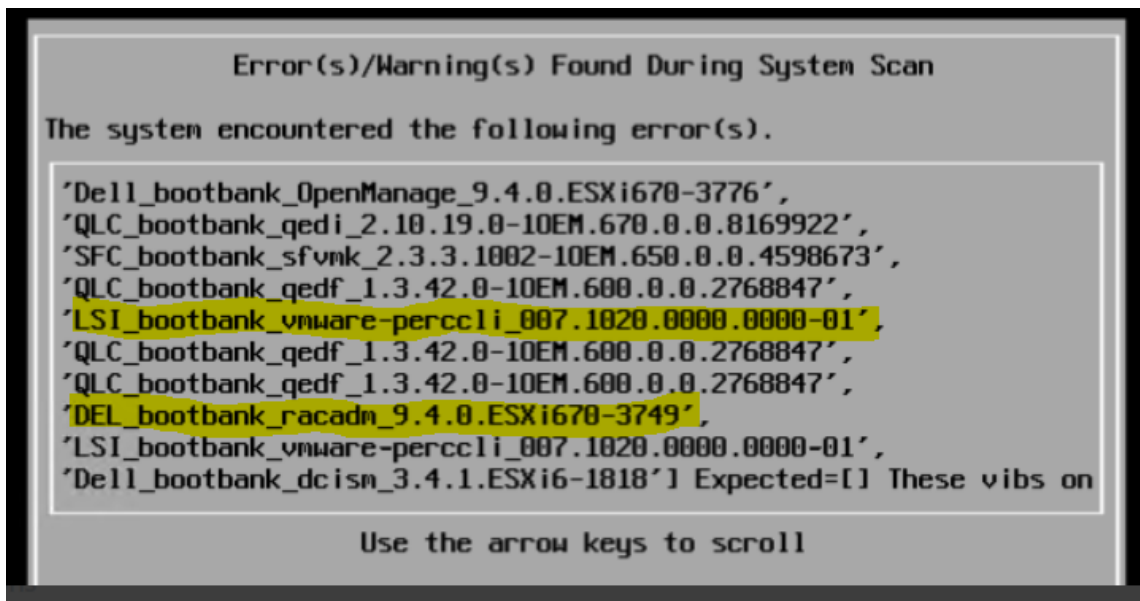
It is required to uninstall the respective VIBs from vSphere 6.x versions prior attempting to upgrade, failing to do this and attempting to upgrade results in a failure mentioned in the following screenshot.

Below is a snapshot indicating the specific upgrade error when the standalone utility packages are installed on 6.x branch of ESXi prior performing 7.0 upgrade.

Figure 8 Upgrade error when the standalone utility packages are installed

Use the following commands to remove PERC CLI and Dell EMC iDRAC tools VIB:

- `esxcli software vib remove -n vmware-perccli`
- `esxcli software vib remove -n racadm`
