Dell DL1300 Appliance Release Notes

This document describes important product information and restrictions for the Dell DL1300 Appliance running AppAssure and Rapid Recovery.

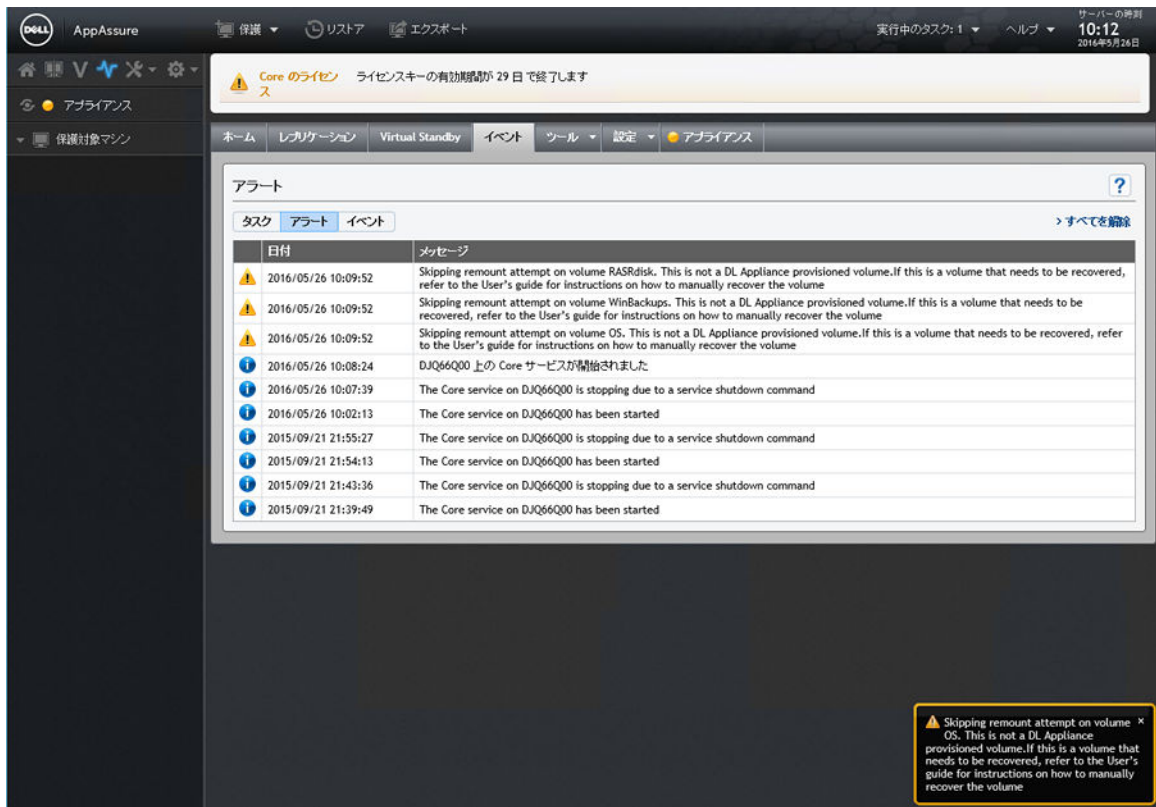
At times nonlocalized messages are displayed in the AppAssure Core and the AppAssure Event log

Description	Sometimes nonlocalized messages are displayed in the AppAssure Core (lower-right corner of the screen) and the AppAssure Event log.
Workaround/Solution	Restart the Core, WMI and SRM Web Service services, then empty the browser cache and restart the browser.

Figure 1. Nonlocalized messages displayed in the AppAssure Core and the AppAssure Event log
