# Emulex<sup>®</sup> Drivers for VMware ESXi

**User Guide**  
**Release 12.8**

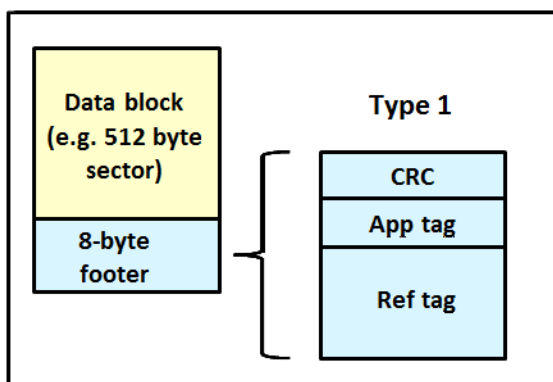
**Figure 1: Data Block Showing Type 1 DIF**

The following figure shows a data block (with a 512-byte sector) with the 8-byte footer attached to the end. The contents of the 8-byte footer are shown with the fields that make up the Type 1 DIF; the Guard tag, the App tag, and the Ref tag. The App tag is not used by the `lpfc` driver.

When data is written, the DIF is generated by the host, or by the adapter, based on the block data and the LBA. The DIF field is added to the end of each data block, and the data is sent through the SAN to the storage target. The storage target validates the CRC and Ref tag and, if correct, stores both the data block and DIF on the physical media. If the CRC does not match the data, the data was corrupted during the write. A Check Condition is returned to the host with the appropriate error code. The host records the error and retransmits the data to the target. In this way, data corruption is detected immediately on a write and is never committed to the physical media. On a read, the DIF is returned along with the data block to the host, which validates the CRC and Ref tags. Because this validation is done by the hardware, it adds a very small amount of latency to the I/O.

The format of the Guard tag can optionally be an IP checksum instead of the CRC mandated by the T10 DIF. This can be beneficial because the initiator host uses less CPU overhead to generate an IP checksum than it does with a CRC. The IP checksum is typically passed as the Guard tag between the initiator host and the adapter. The adapter hardware will translate the IP checksum into a CRC, or vice versa, on data being sent to or received from the wire. The CRC is called a DIF protection type, and the IP checksum is referred to as a DIX protection type.

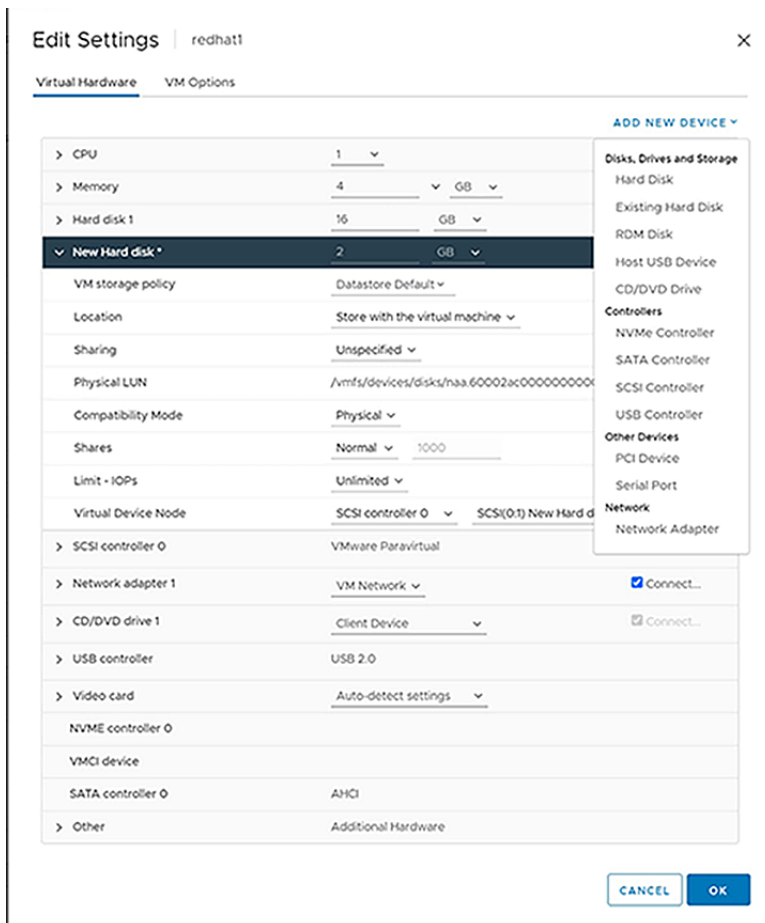
Figure 3: VM With a Mapped Raw LUN

Select **Edit Settings > Virtual Hardware**. Click **New Hard disk**. The existing RDMs are displayed, see [Figure 3](#).
