Control Processor Blade (CP8)

Replacement Procedure

Supporting Fabric OS v6.0.0 through v6.3.x (as compatible with supported hardware)

Supporting PowerConnect B-DCX-4S and PowerConnect B-DCX Backbone

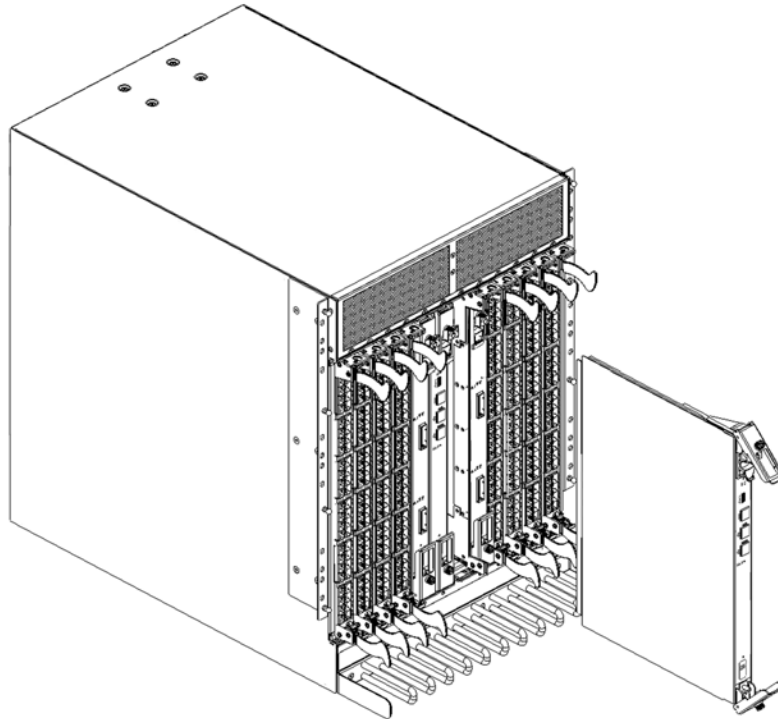
FIGURE 1 Control processor blade (CP8) in a DCX chassis

- Turn the CP blade off and notify the backbone of a hot swap request by sliding the slider switch in the top ejector down to the off position ([Figure 1](#)).
- Wait until the active CP LED on the functioning CP blade is lit. Remove the faulty CP blade.

1. Remove the chassis door (see the *Chassis Door Replacement Procedure* for your chassis).
2. Power off the faulty blade by sliding the slider switch in the top ejector down to the off position ([Figure 1](#)).
3. Disconnect all cables from the faulty (standby) CP.
4. Unscrew the thumb screw from both ejectors using the Phillips screwdriver.
5. Lever open both ejector handles simultaneously to approximately 45 degrees and pull the CP blade out of the chassis ([Figure 1](#) and [Figure 2](#)).

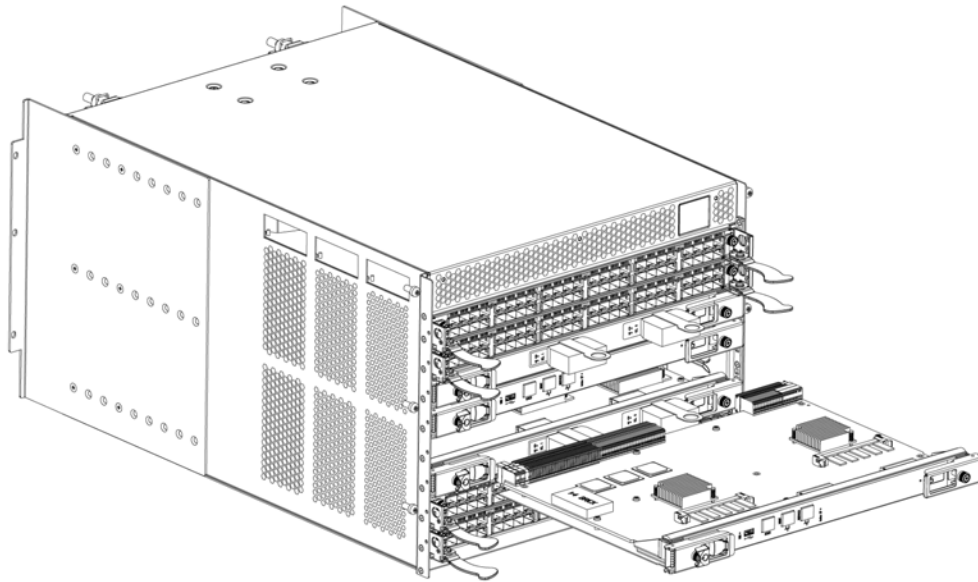
FIGURE 2 Control processor blade (CP8) in a DCX-4S chassis
